DEPARTMENT OF TRANSPORTATION

Contract #: 04-0120F4Cty: SF/ALA Rte: 80 PM: 13.2/13.9File #: 69.28**WELDING INSPECTION REPORT****Resident Engineer:** Pursell, Gary**Address:** 333 Burma Road**City:** Oakland, CA 94607**Report No:** WIR-013225**Date Inspected:** 16-Mar-2010**Project Name:** SAS Superstructure**OSM Arrival Time:** 700**Prime Contractor:** American Bridge/Fluor Enterprises, a JV**OSM Departure Time:** 1900**Contractor:** Zhenhua Port Machinery Company, Ltd (ZPMC), Changxing Island **Location:** Shanghai, China**CWI Name:** Zhou Cheng/Zhu Zhong Hai**CWI Present:** Yes No**Inspected CWI report:** Yes No N/A**Rod Oven in Use:** Yes No N/A**Electrode to specification:** Yes No N/A**Weld Procedures Followed:** Yes No N/A**Qualified Welders:** Yes No N/A**Verified Joint Fit-up:** Yes No N/A**Approved Drawings:** Yes No N/A**Approved WPS:** Yes No N/A**Delayed / Cancelled:** Yes No N/A**Bridge No:** 34-0006**Component:** OBG Components**Summary of Items Observed:**

Bay#19-Suspender Bracket.

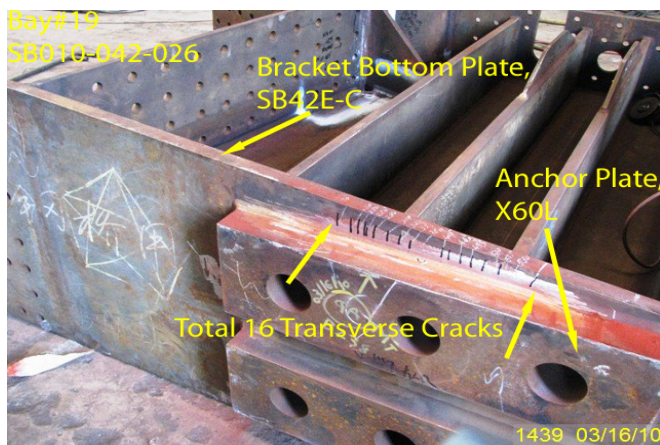
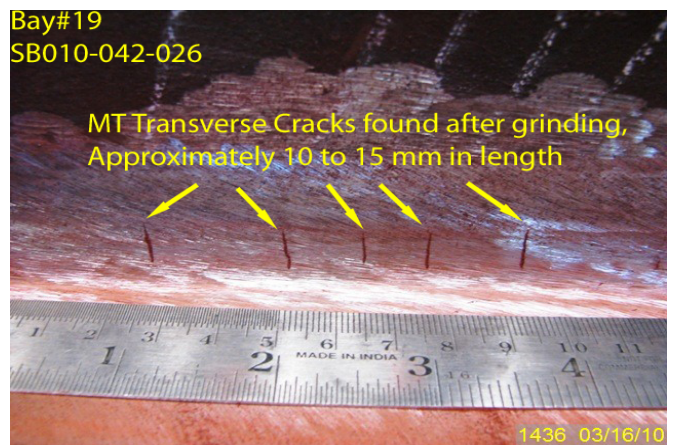
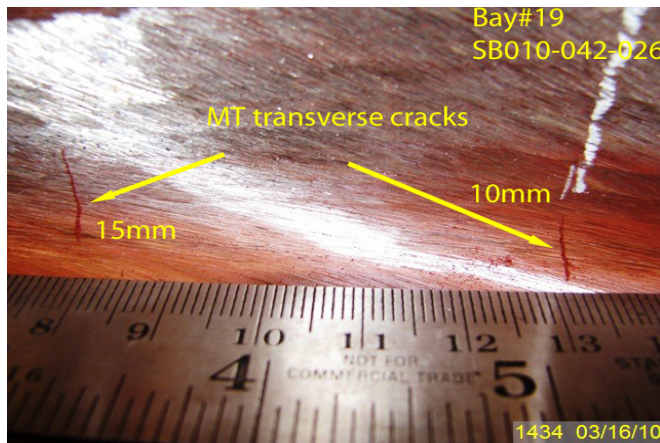
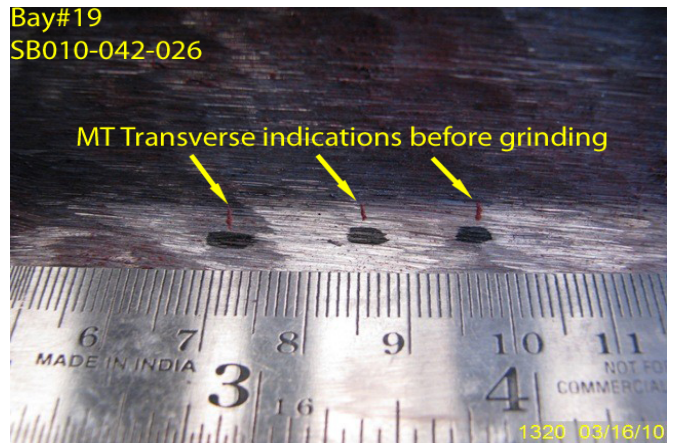
Bay#19, Suspender Bracket

During random Quality Assurance Magnetic Particle Testing (MT) review of the Suspender bracket welds, this Quality Assurance Inspector (QA) discovered the following issue:

-Total Sixteen (16) Transverse Cracks measuring approximately 15mm to 10mm in length.

-The weld is identified as: SB010-042-026.

-The weld is a seal weld joining the bracket bottom Plate (SB42E-C) to the anchor plate (X60L).

- This weld is designated as non Seismic Performance Critical Member (non SPCM) according to approved drawing (SB10).

-Total fifteen (15) transverse cracks found by ZPMC MT technician on 03-15-2010 and this weld was repaired by ZPMC personnel by SMAW process on 03-15-2010 without the prior approval of the engineer or utilizing an approved critical weld repair procedure (CWR).

- (SB008-036E-031, 043, 055, 067, 001, 005, 12~17, 026, 032, 077)
- (SB008-036E-031, 043, 055, 067, 001, 005, 12~17, 026, 032, 077)
- (SB008-036E-031, 043, 055, 067, 001, 005, 12~17, 026, 032, 077)
- (SB008-036E-031, 043, 055, 067, 001, 005, 12~17, 032, 077)
- (SB008-036E-26)- Found Transverse crack
